CORROSION IN LOW NO_x FIRING CONDITIONS

W.M.M. Huijbregts *, J.B. Janssen **, O.C.J. Rens **

Power-Gen '98, Milan, June 9-11, 1998

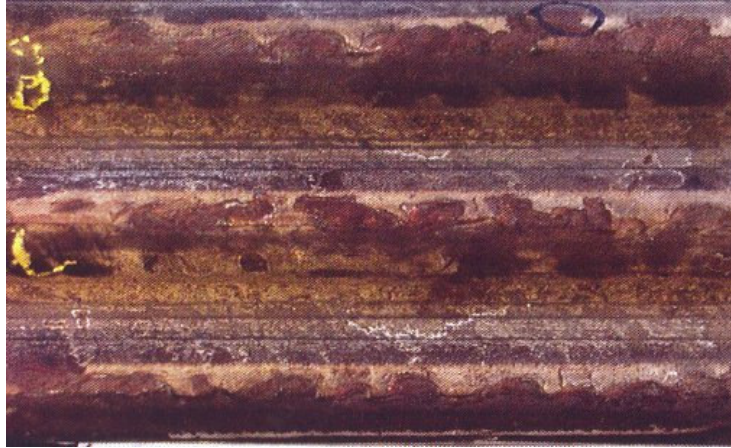
1. In the area of the soot blowers erosion-corrosion of the tube occurred (Figure 1). Because of the poor quality of the oxide layer and the high pressure of the soot blowers, the scale was blown away regularly.

Figure 1 Tubes damaged by erosion-corrosion because of the erosive action of the soot blowers

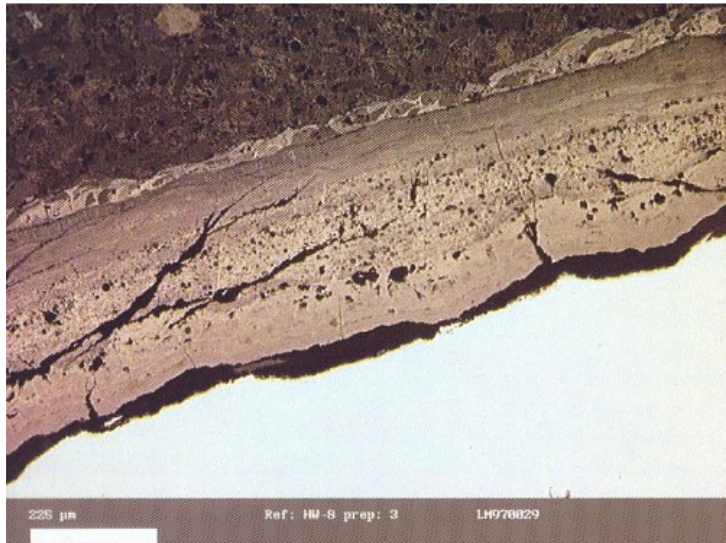
2. The scale on the most corroded tubes in the side walls consists of various layers:
 - a topotactically grown oxide layer with many sulphides in it (Figure 2). The topotactically grown oxide layer should normally provide the protection from severe corrosion. Because of the porous structure and the large amount of sulphides, the protection effectiveness of this layer is very low.

Figure 2 The topotactically grown corrosion scale. In the oxide layer many sulphides are found. The sulphides have also grown in the cracks of the oxide

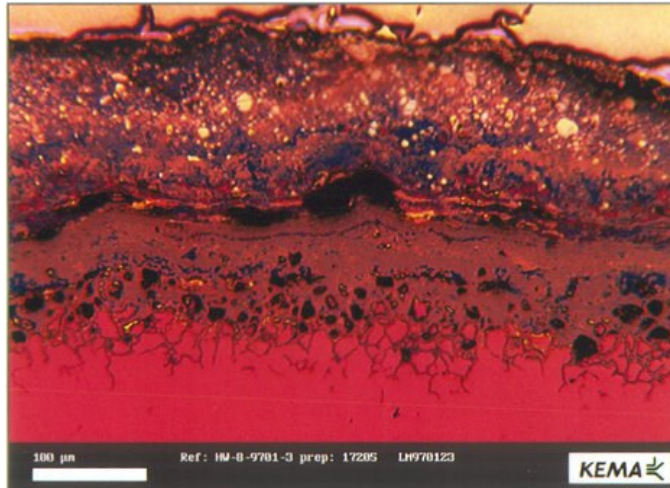
- Besides, at the oxide-metal interface the element Cl was found and sometimes also intergranular corrosion (Figure 3).

Figure 3 At the metal-oxide interface the element Cl is sometimes found. In a few cases this resulted in severe intergranular corrosion

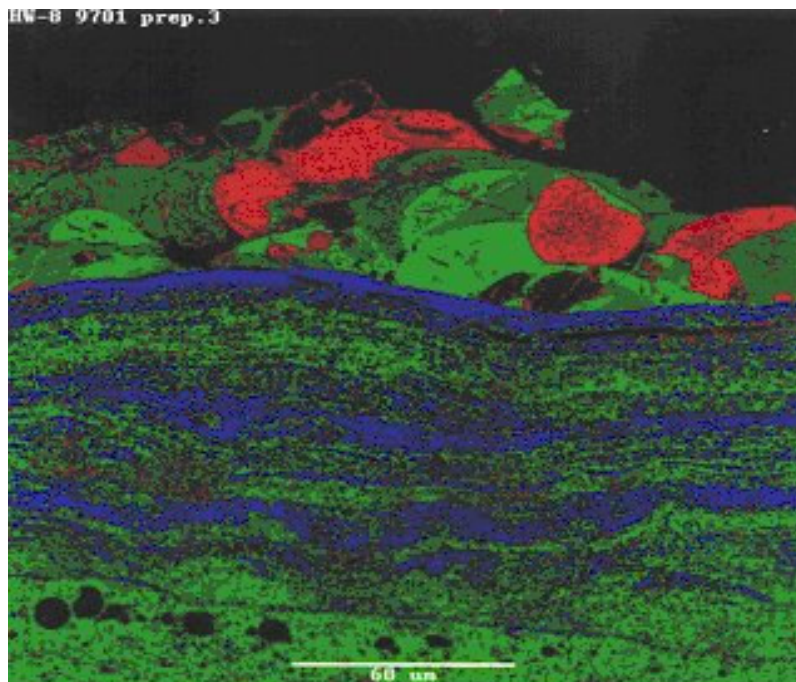
- an epitaxial layer with many coarse crystalline sulphides and oxides and in between fly-ash particles the sulphides were present as FeS and as FeS₂, the latter species indicating a relatively severe sulphidising atmosphere
- a deposit layer of fly-ash particles; in this layer an enrichment of heavy metal compounds was found (Figure 4) The metals found were: Pb, Zn, Sb, Sn, Ni, Cu, Ge, Se and As. It was typical that the heavy metals were mainly present in the outside deposit layer. A very sharp border was often present under which the heavy metals were not noticed.

Figure 4 A Scanning Electron Microscope image, the places of presence of heavy metals are blue (detail of Figure 1).

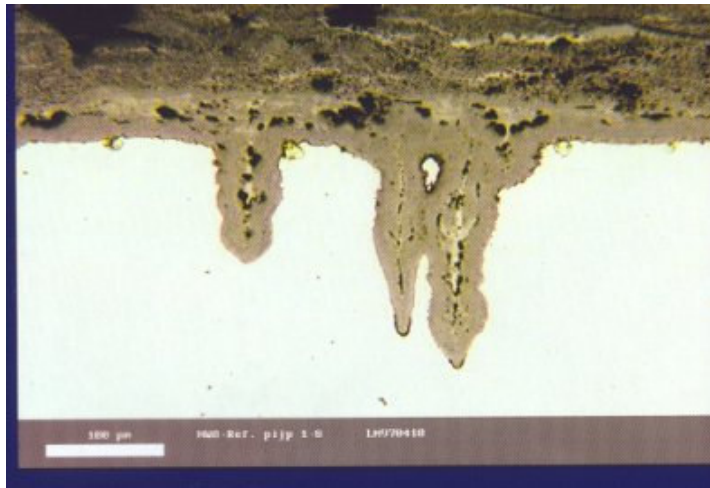
- many tubes had deposits of black carbon, originating from the flame impingement process.
3. Some of the tubes at the rear wall in the neighbourhood of the burners showed first indications of Alligator Skin Cracking (ASC, Figure 5) When a sulphidising atmosphere is present under moderate thermal fatigue conditions the oxide scale is less protective and the cracks are deeper and filled with sulphide containing oxide. In this situation the phenomenon is called ASC. Even with the moderate amount of chlorine content in the coal, volatile Cl compounds, like HCl and FeCl₂, will condense in reducing atmospheres at the coolest places in the oxide layers, the oxide-metal interface. The element Cl is also often found at the crack tip of the ASC cracks.

Figure 5 Typical Alligator Skin Cracks in one of the tubes at the rear water wall

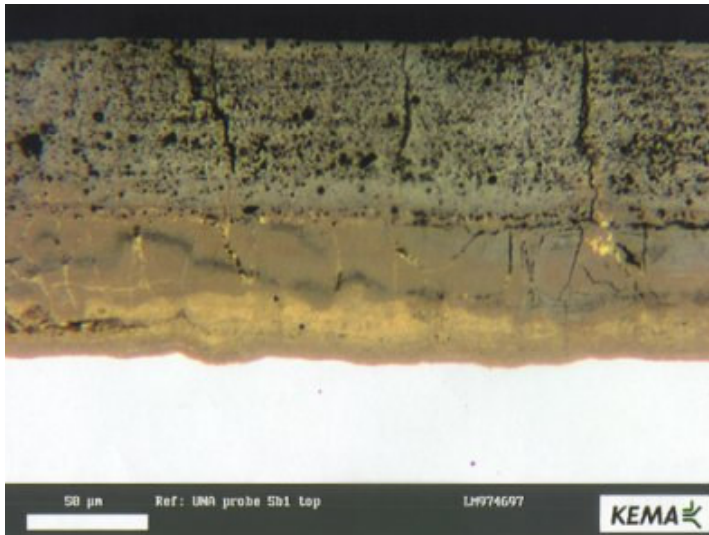
microscopic techniques. The scale still contained many sulphides and a thick deposit layer of fly-ash and even heavy metal compounds were noticed (Figure 6).

Figure 6 The high-sulphide layer on the corrosion probe, after 4 weeks of operation

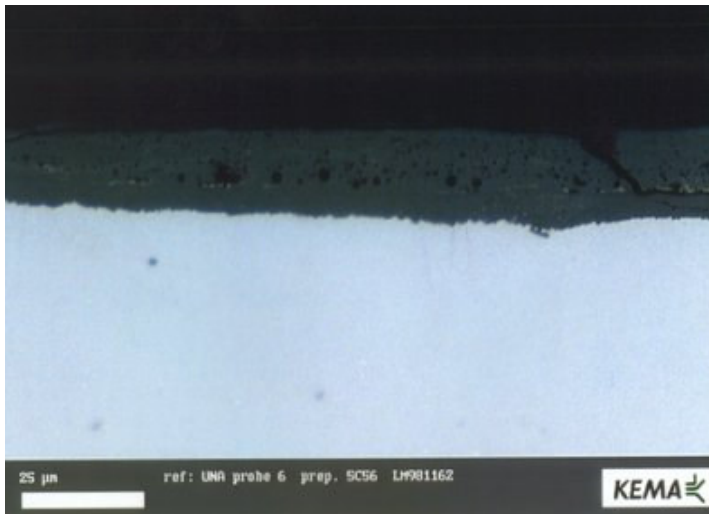
After a period of approximately 4 weeks under conditions with adjusted burners, the oxide layer improved. Fewer sulphides and deposits were present on the probes (Figure 7).

Figure 7 The oxide layer after adjustment of the burners and air curtain introduction. The layer is more protective now

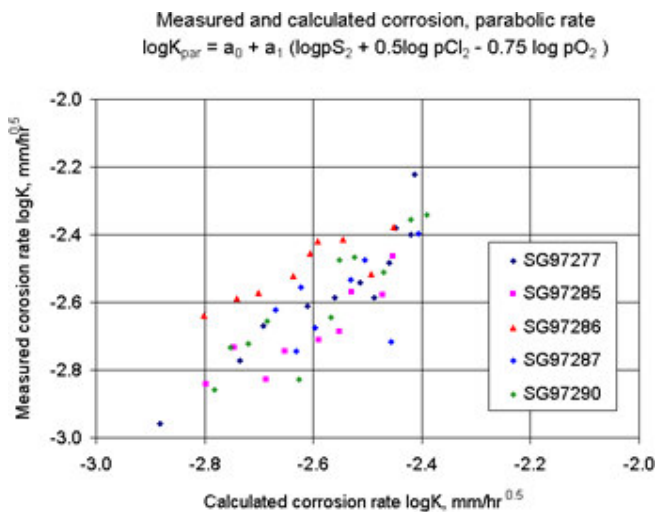
In Figure 8 the measured and calculated K values are presented. In more recent publications such regression data were also published (4,5).

Figure 8 The calculated and measured corrosion rate constants in a sulphidising gas

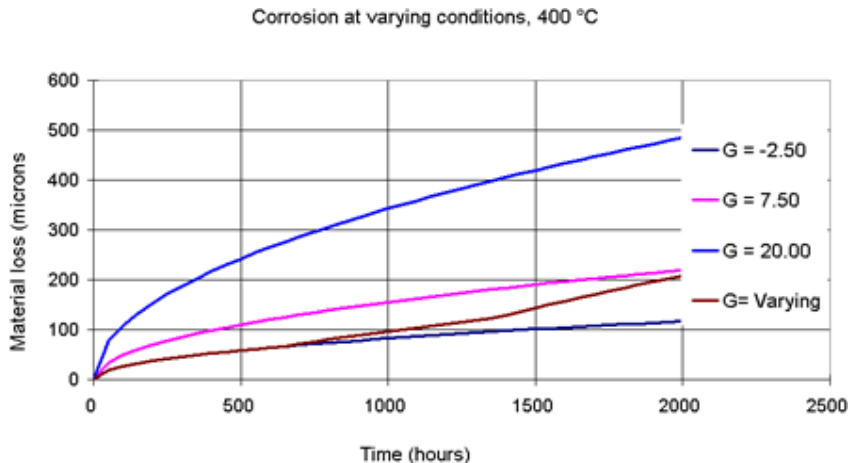
Knowing these constants and the gas compositions on the water wall, the corrosion rate of the tubes can be calculated. In Figure 9 an example has been given of the thickness of the corrosion scale for the Hemweg 8 unit, assuming various gas factors for a metal temperature of 375 °C.

Figure 9 An example of calculating the corrosion at 375 °C of the tube wall based on the data of the gas measurements. A parabolic corrosion rate has been assumed
