## Severe corrosion in a waste incinerator plant due to flue gas and steam leakage

Ton de Weijer and Wally Huijbregts

Anti-corrosion methods and Materials Volume 50-2003-pg 334-340

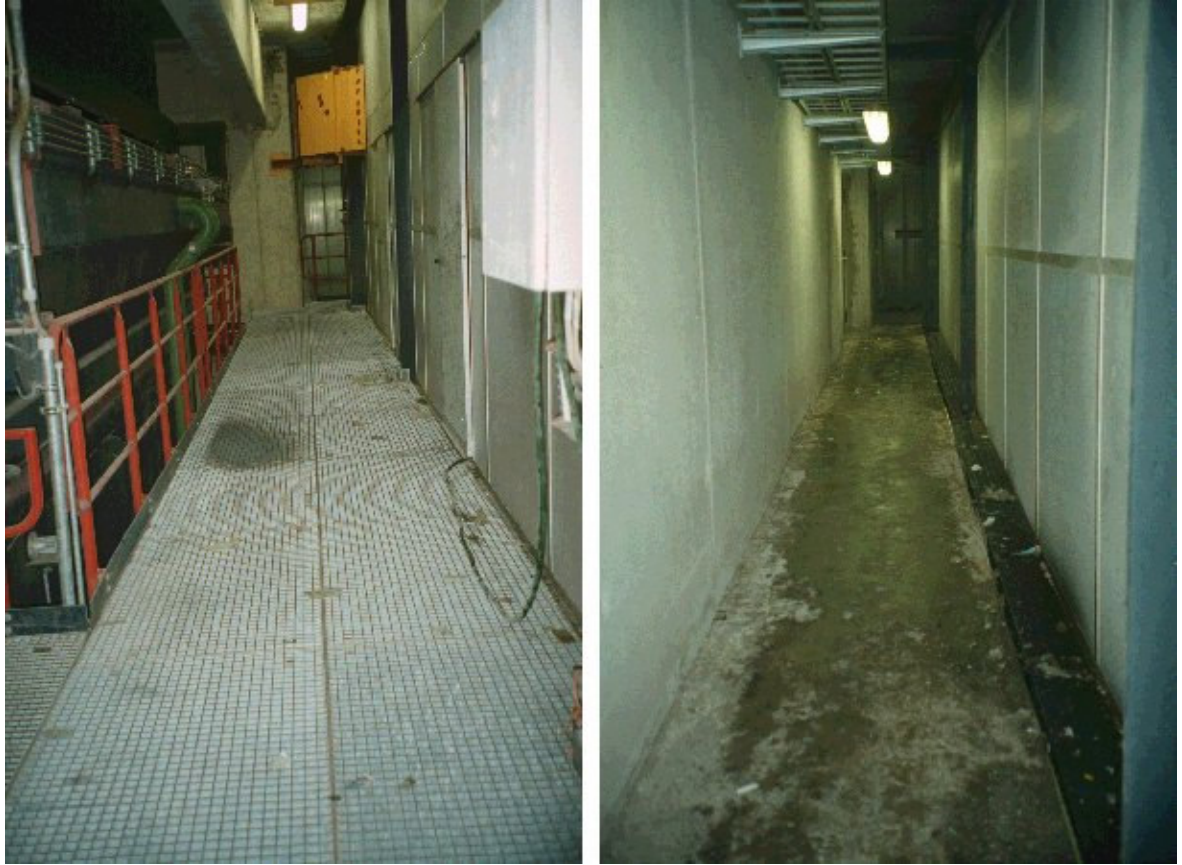
The steel outer walls of the building were corroded severely and had to be replaced and steel construction girders had to be renovated, as did galvanised gangways.

Figure 1 Corroded galvanised gangways

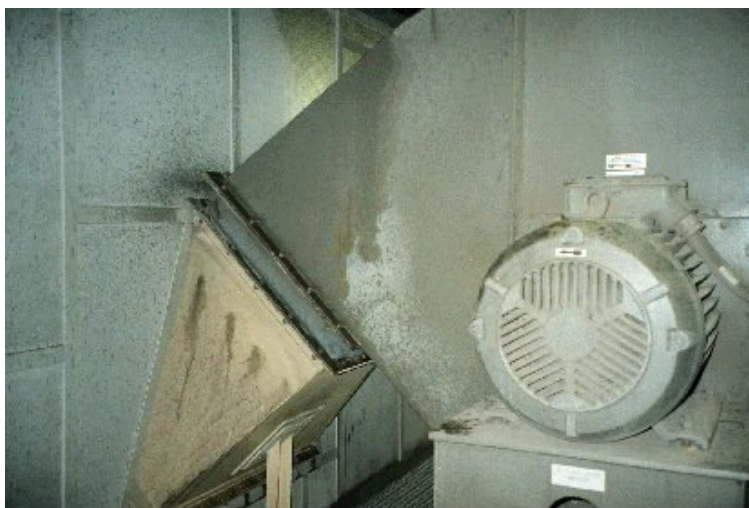
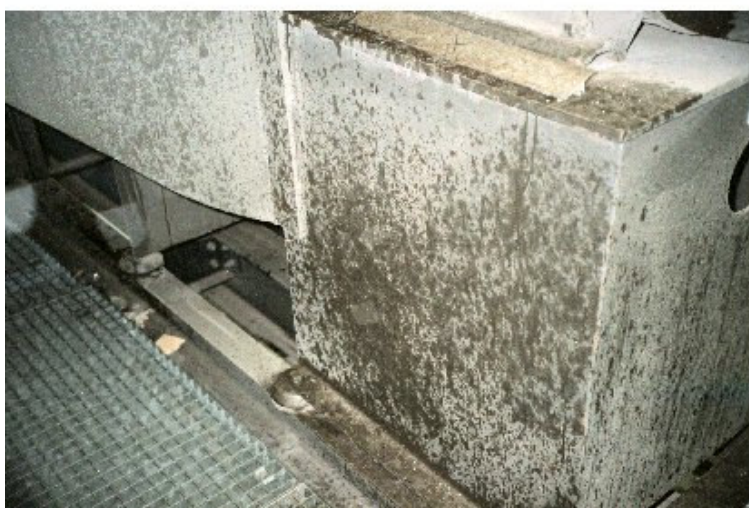
Figure 2 Corroded ventilator

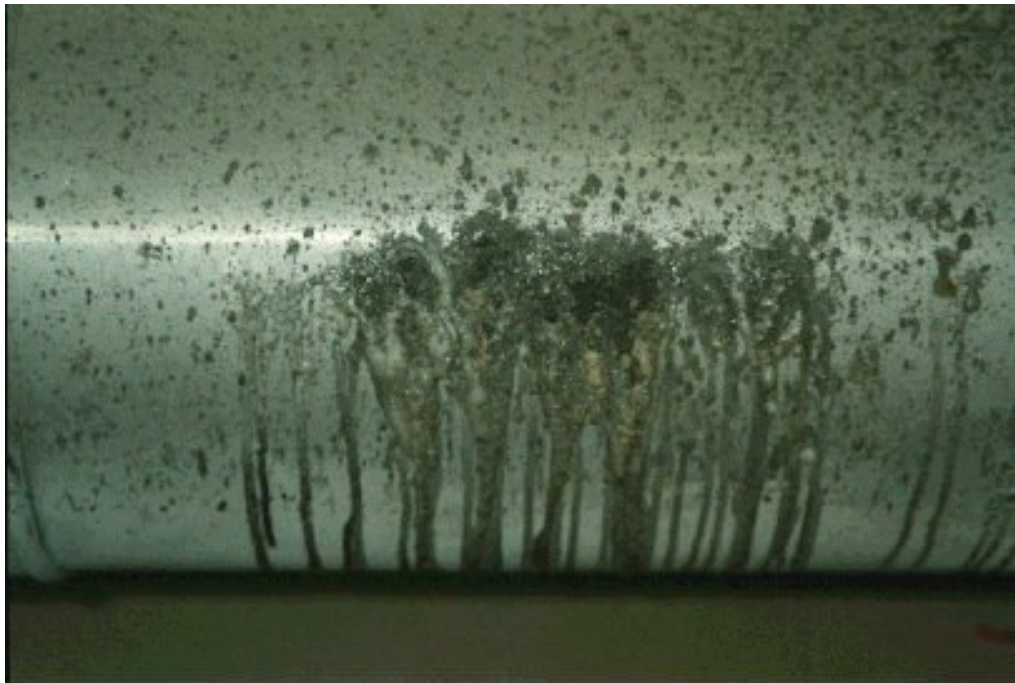
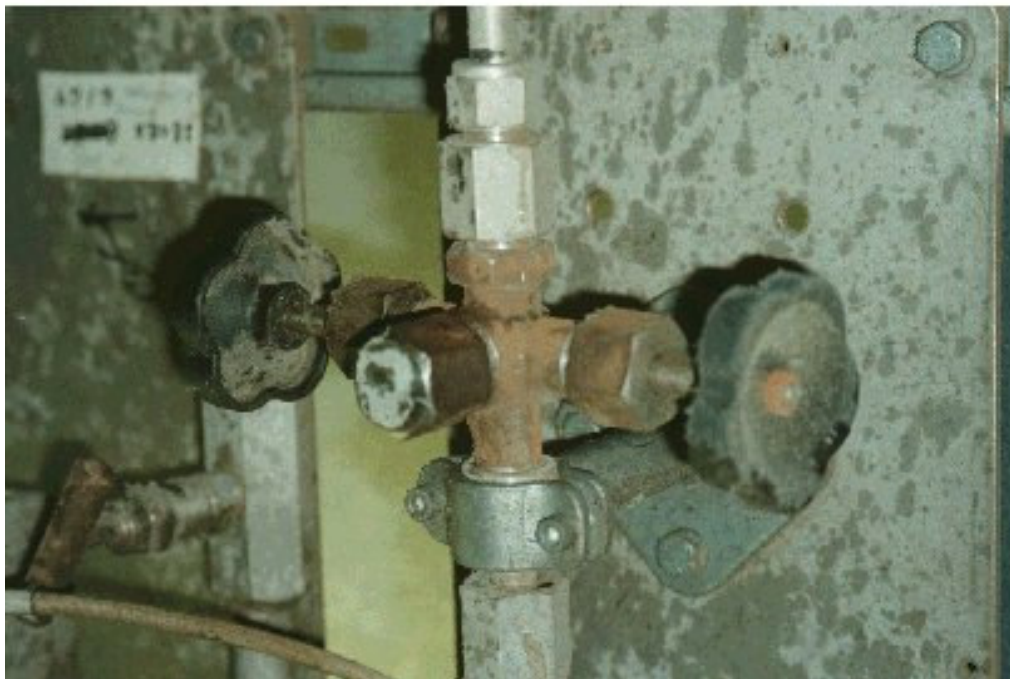
Figure 3 Corroded aluminium isolation plates and steel valves

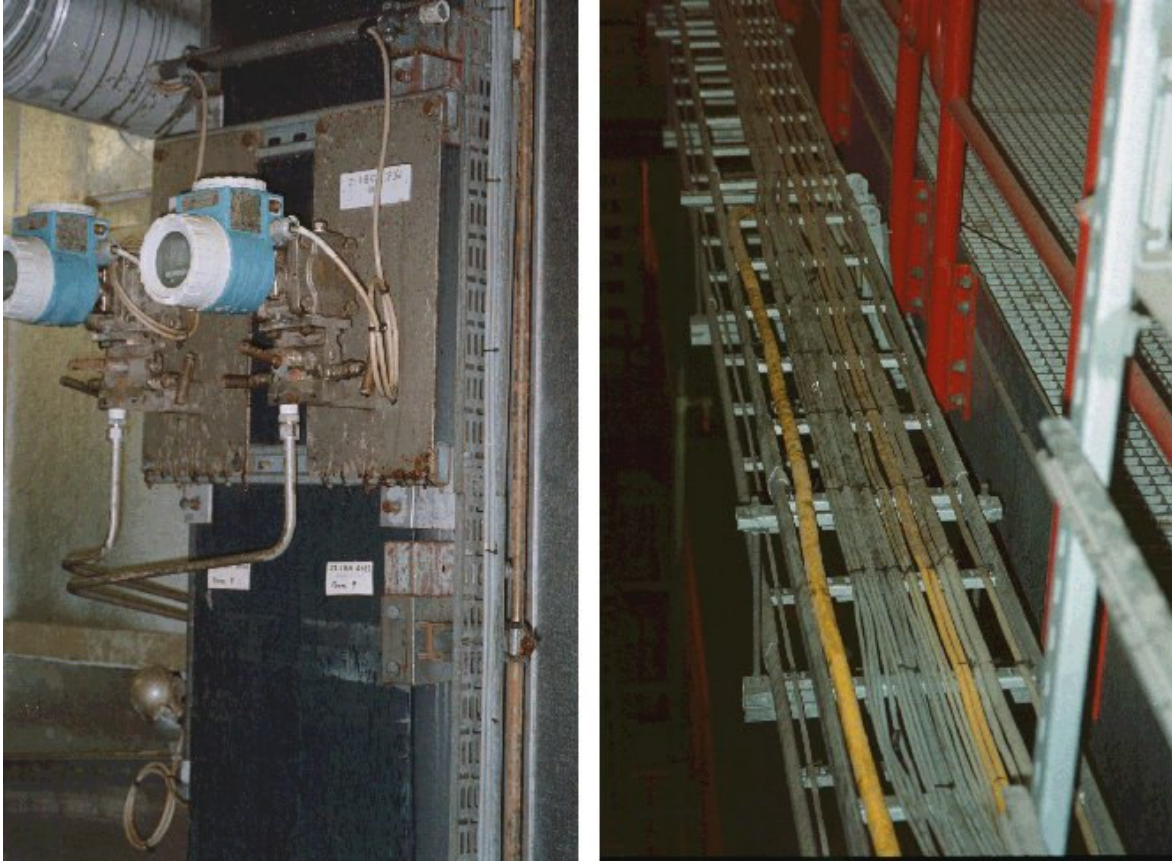
It was determined that the cable trays required replacement.

Electric process equipment also had to be checked. Fortunately, most of the instrumentation and switchgear housings were watertight and damage to these components was limited.

Figure 4 Corroded switches and damaged cable trays

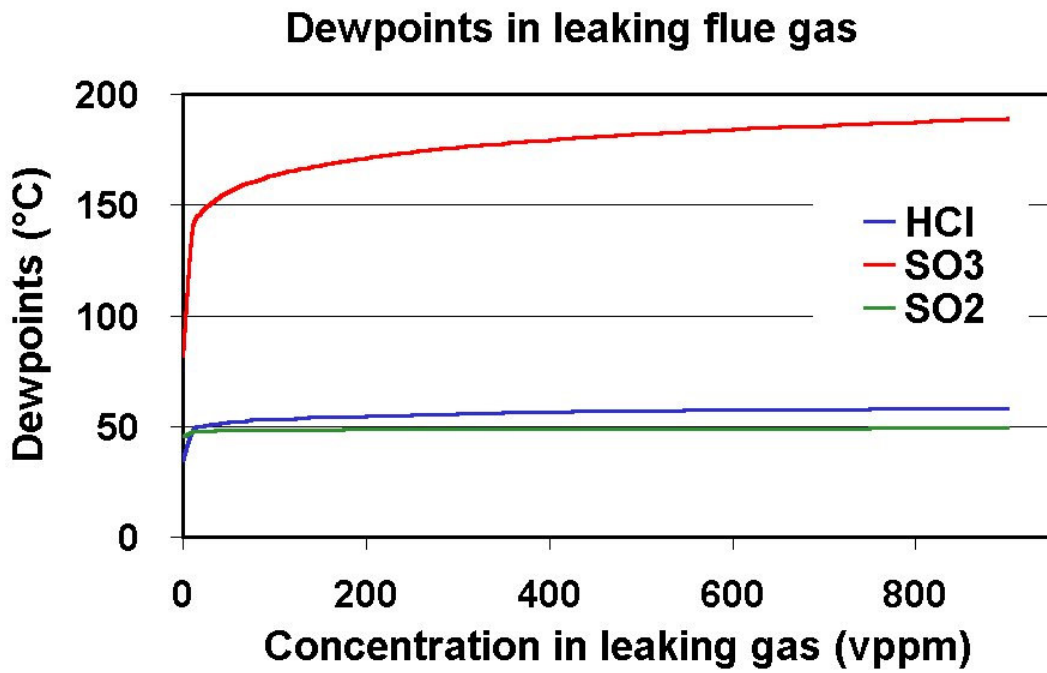
Figure 5 Dewpoints of the leaking flue gas inside of the isolation

The SO<sub>3</sub> concentration decreased as a result of dilution in the lagging void from a maximum of 18 vppm at the membrane wall down to the calculated value of 0.033 vppm (diluted flue gas in the boiler house). The calculated dewpoints for these concentrations were 146 and 58 °C, respectively. As soon as the flue gas escaped from the boiler, droplets of 80 per cent sulphuric acid were formed.

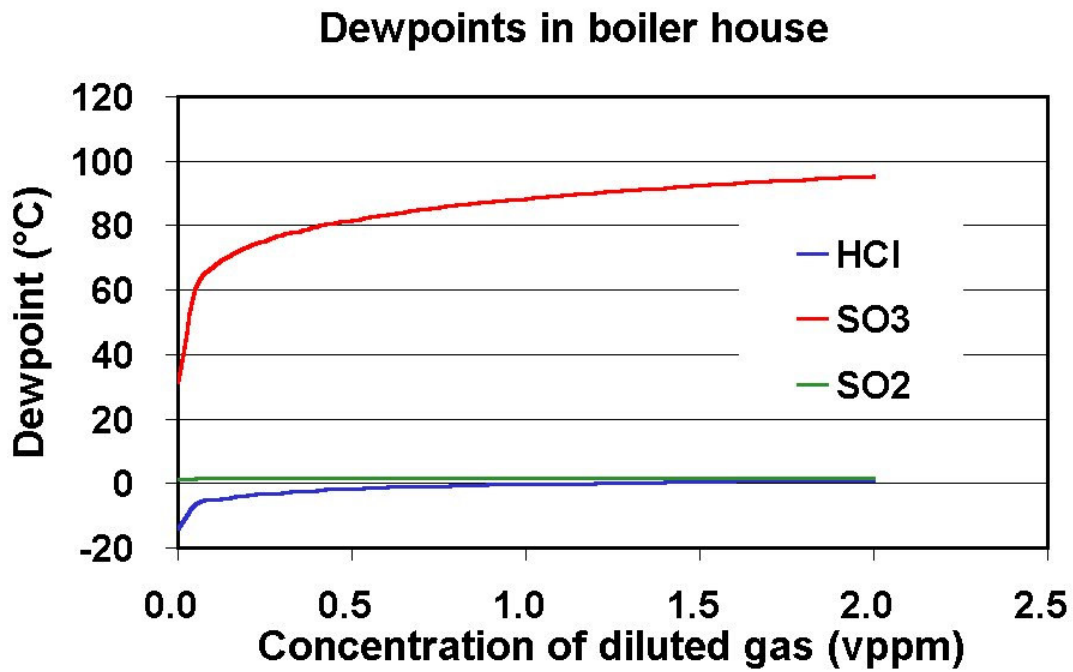
Figure 6 Dewpoints of the diluted flue gas in the boiler house.

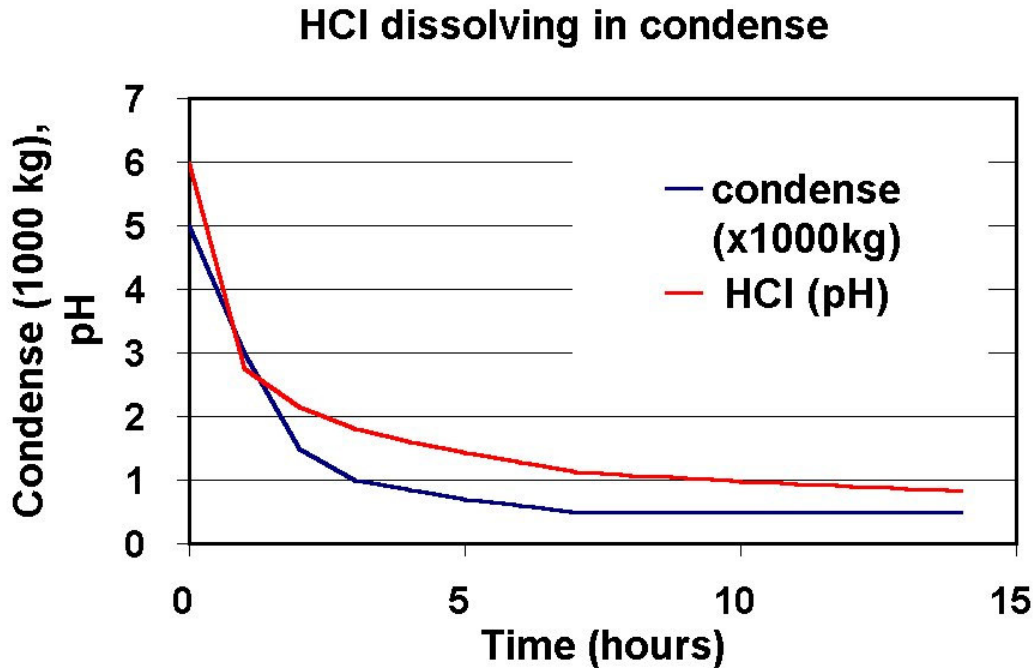
The results of the calculations are given in Figure 7. This shows that the water droplets would have become very acidic within a short time. This explains the extensive corrosion damage.

Figure 7 Decrease of pH value of the condensed moisture, depending on the assumed decrease of amount of condensed moisture in the boiler house

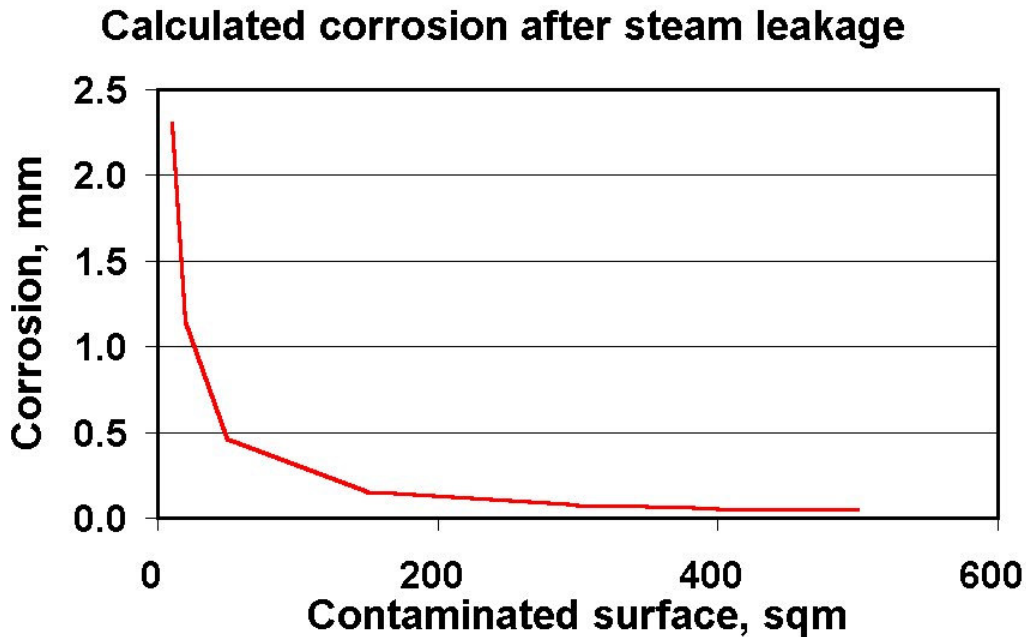
The calculated corrosion rate of steel after a period of 1400 h of operation is given in Figure 8.

Figure 8. Calculated corrosion rate of steel after a period of 2 months.
