# CORROSION IN HEAT EXCHANGERS, THE VALUE OF MATERIAL SPECIFICATION

Huijbregts W.M.M., Uilhoorn F., Wels H.C.

Euromat 1997. Materials, functionality & design, Conference Maastricht, 1997

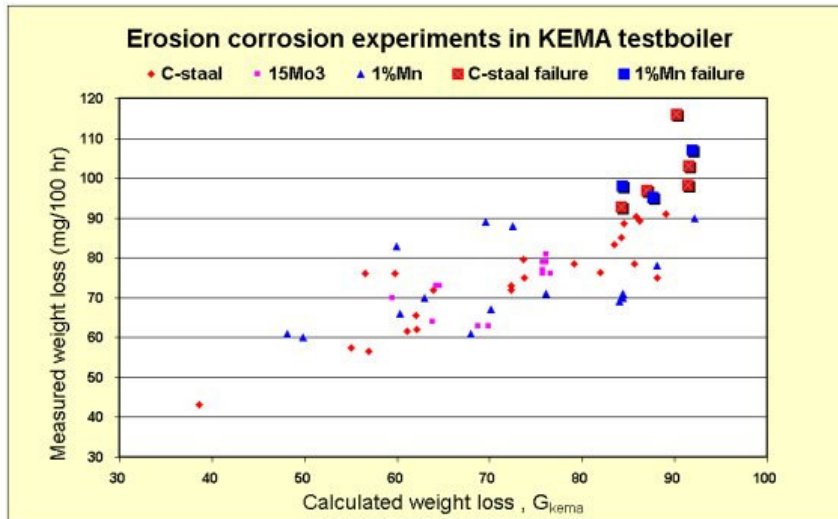
Figure 3: Measured and calculated weight loss of carbon steels from the KEMA erosion-corrosion tests.

The erosion-corrosion resistances of carbon steels were determined in a jet stream of a water-steam mixture at a steam velocity of 960 m/s and an oxygen content less than 2 ppb [6]. After an exposure time of 100 hours the weight loss was determined. These weight losses were correlated with the steel composition, which resulted in the regression formula, mentioned below.

The calculated  $G_{KEMA}$  values were in the range of 40 up to 100 (Figure 3).

Our experience is that in all observed erosion-corrosion failures in water-steam systems up to now the corroded steels had a  $G_{KEMA}$  value more than 80. In Figure 3 these cases have been plotted. Because small amounts of Cu, Cr and Mo improve the resistance to erosion-corrosion very much, a large variation in erosion-corrosion resistance of carbon-steel exists. Accidentally one heat can possess a much higher resistance compared to other heats from the same steel specification. Thus, erosion-corrosion resistance of the material is nowadays still a matter of "Russian roulette".

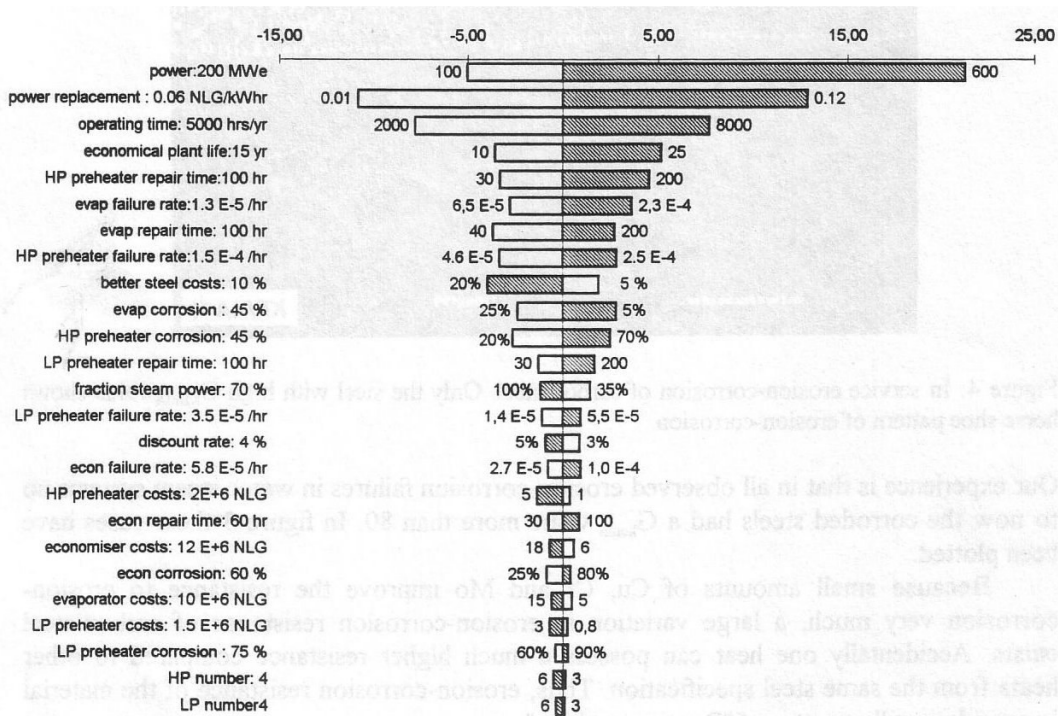
Figure 5. Variation in Return On Investment for all components- base case value 9.1 million NLG.

From the database of failures and forced outages of production units in the Netherlands the total forced unavailability and the percentage of production losses because of erosion-corrosion was estimated for evaporators, low pressure and high pressure preheaters and economisers. In these calculations the lowest and highest price for the modified steel was assumed to be 5 and 20% more expensive with 10% of the Base Case value. It can be concluded that for a 200 MWe plant the total Return On Investment over 15 years for the base case situation amounts about 9 million NLG. Most of the value is in the evaporator (4 million NLG) and in the HP preheater (3.8 million NLG). The variables that count are large power, base load and high power replacement costs. For small power plants with only a limited number of operating hours, the additional investment does not pay. It is worthwhile to choose better steels for erosion-corrosion sensitive components. The results of the calculations for Return On Investment for the various parameters have been given in the tornado diagram in Figure 5.

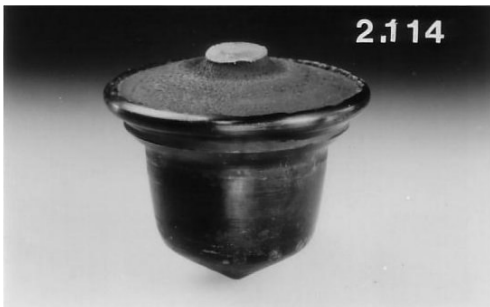
### Case 2

A spindle from a condensate effluent valve of a low pressure preheater was coated only partly with a chromium steel (9% Cr). see Figure 4. It might be considered that on the top of the spindle the coating was not necessary because in general there are no corrosion failures. But because of the too low Cr-equivalent the carbon steel was corroded. The  $G_{KEMA}$  was 83.1.

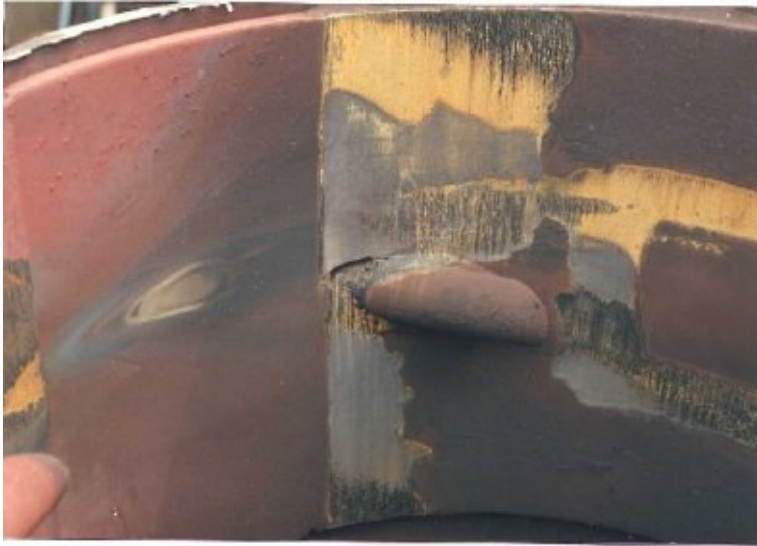
### Case 5

In the KEMA experimental boiler, erosion-corrosion occurred in a steam pressure drop vessel in which steam expanded and where the water steam jet hit a baffle plate in the vessel. See Figure 6. After 10 years of operation, there was a leakage in the baffle plate and the vessel wall. The steel plate (10 mm thick) and the vessel wall (5 mm thick) were corroded and a leakage occurred. The  $G_{\text{KEMA}}$  of the steel plate was 74.1. For such situations (a baffle plate for protecting the vessel to the wet steam flow) steel with a lower  $G_{\text{KEMA}}$  is required.

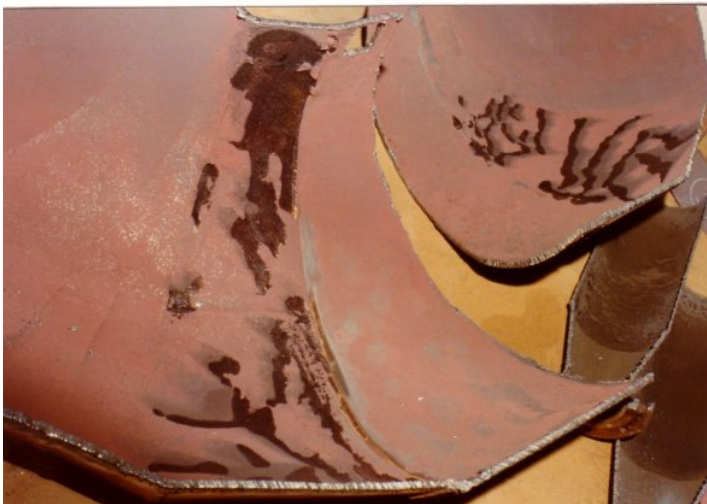
### Case 6

A pipe behind the BWR water separator was constructed by welding bent steel plates. One of those plates had been attacked severely. The other plates, both upstream and downstream, had not been attacked. The corroded plate showed a different chemical composition. The  $G_{\text{KEMA}}$  of the corroded steel was 91.5, whereas the values of the uncorroded plates were much lower 72.1

The low and high pressure water separators, the pre-waterseparator and the wet steam tubes in the BWR were replaced by stainless steel components in the last few years, before the erosion-corrosion tests were finished.

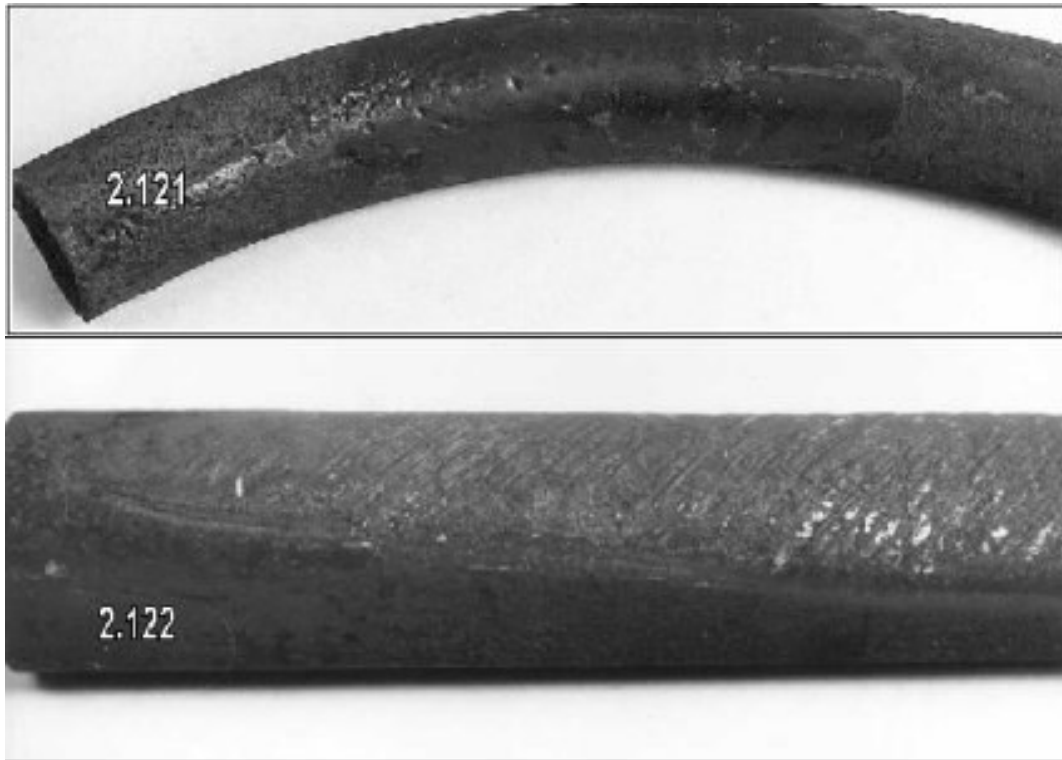
##### Case 11

Two tubes of a backpressure unit were received; one showed severe erosion-corrosion, and the other had only some corrosion spots. The erosion-corrosion  $G_{KEMA}$  for the uncorroded tube 2.121 was much lower than that of the corroded tube (60.9 and 85.7).

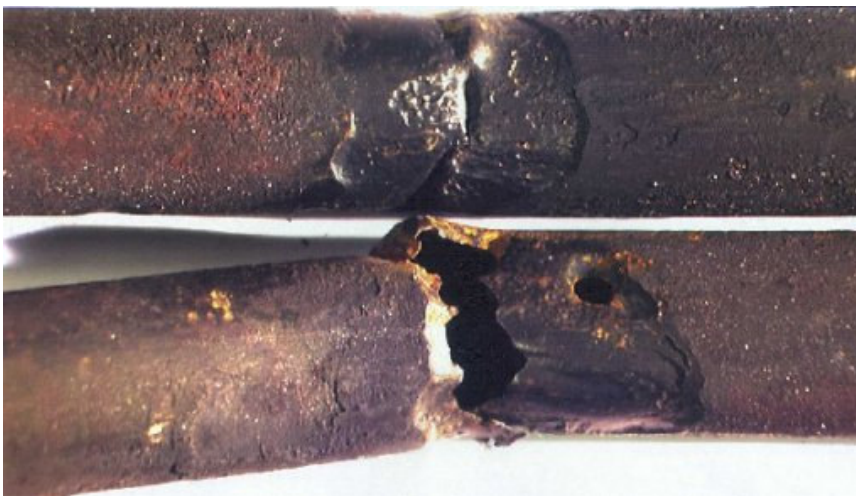
### Case 13

The preheater of a power station suffered local corrosion near the support plates where the flow velocity is high. The  $G_{\text{KEMA}}$  was 90.6. Coarse magnetite crystals were found adjacent to the corroded area. Precipitation of such coarse iron oxide crystals is often observed in case of erosion-corrosion. A second tube with a higher  $G_{\text{KEMA}}$  (71.4) did not show any corrosion.

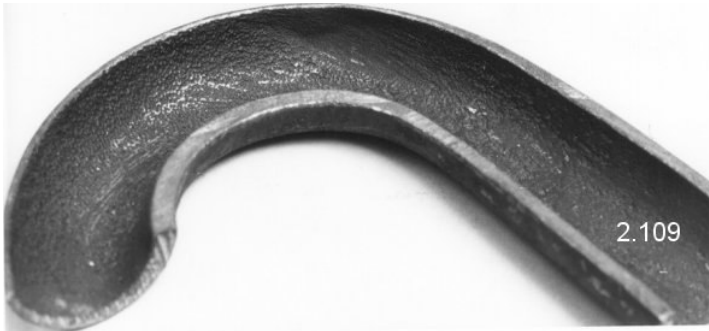
### Case 15

Slight erosion-corrosion was observed on thin tubes in an economiser of a waste heat boiler. The  $G_{KEMA}$  was very high, 90.6.
